# **INDOOR AIR QUALITY ASSESSMENT**

**Memorial Middle School  
502 Cabot Street  
Beverly, Massachusetts**

Prepared by:  
Massachusetts Department of Public Health  
Bureau of Environmental Health Assessment  
Emergency Response/Indoor Air Quality Program  
September 2003

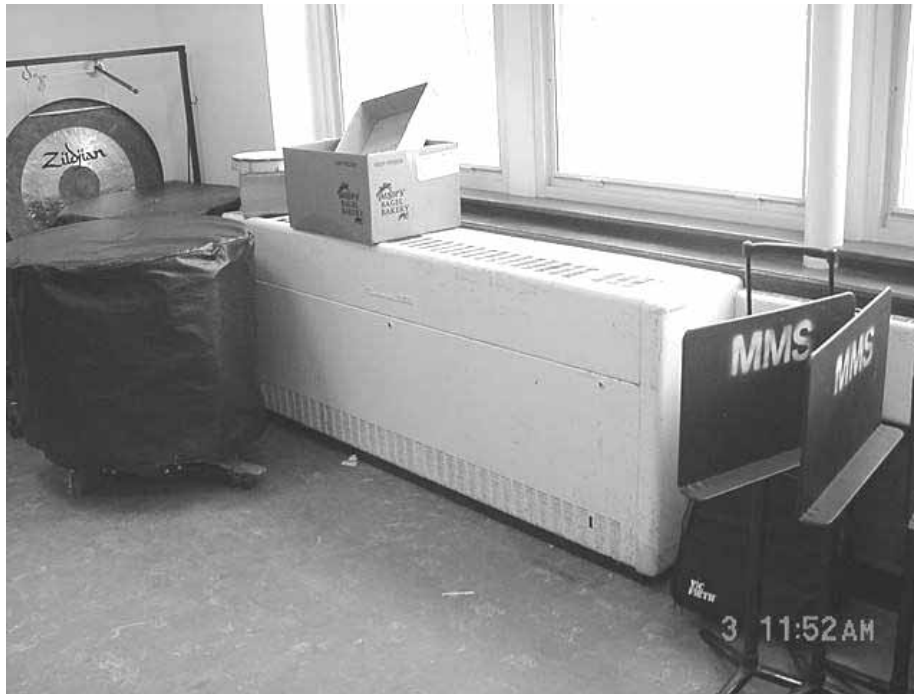
**Picture 1**

Fresh air in classrooms is supplied by a unit ventilator (univent) system (Picture 1). Univents draw air from outdoors through fresh air intakes located on the exterior walls of the building (Picture 2) and return air through air intakes located at the base of each unit ([Figure 1](#)). Fresh and return air are mixed, filtered, heated and provided to classrooms through a fresh air diffuser located in the top of the unit. As discussed, univents were found deactivated throughout the school. Obstructions to airflow, such as papers and books stored on univents and bookcases, carts and desks in front of univent returns were seen in a number of classrooms (Picture 3). In order for univents to provide fresh air as designed, intakes must remain free of obstructions and importantly, these units must remain activated and allowed to operate while these rooms are occupied.

**Typical Classroom Univent**

5. Examine each univent for function. Survey classrooms for univent function to ascertain if an adequate air supply exists for each room. Consider consulting a heating, ventilation and air conditioning (HVAC) engineer concerning the calibration of univent fresh air control dampers throughout the school.

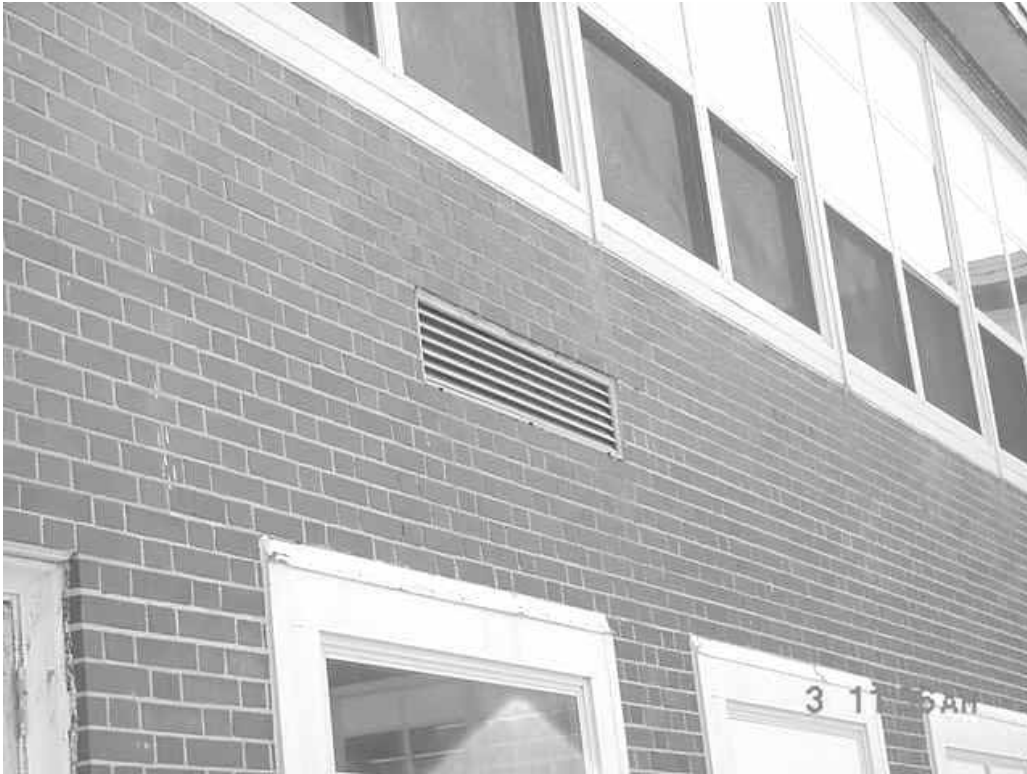
**Picture 2**

**Univent Fresh Air Intake**

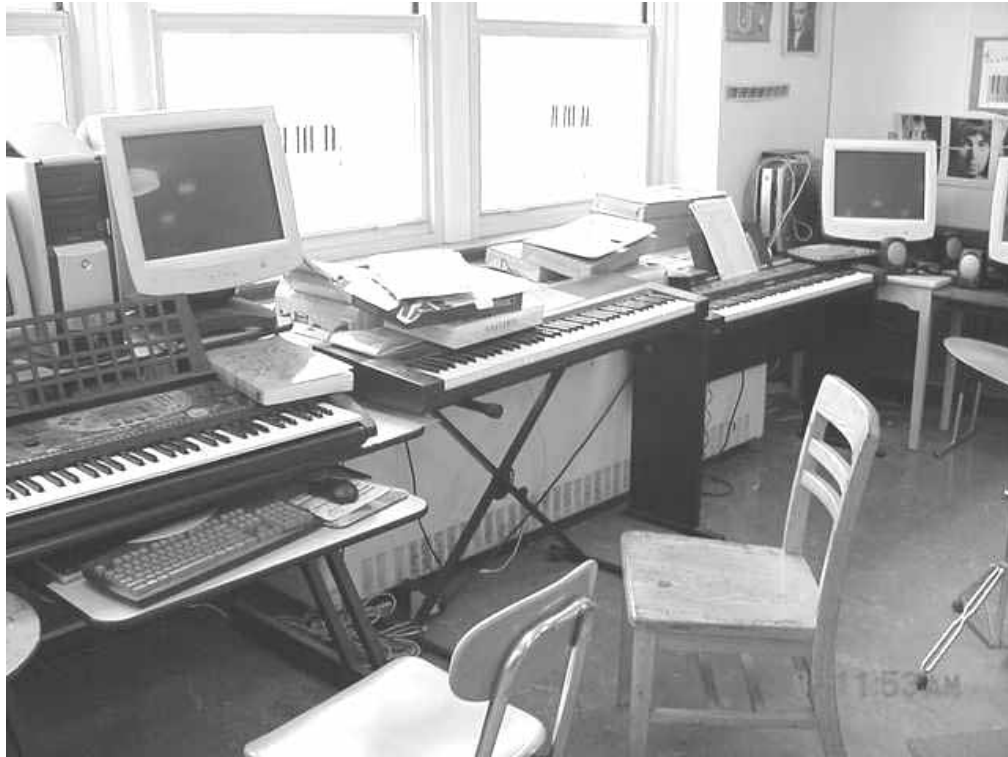
**Picture 3**

**Univent Airflow Obstructed by Various Items**

7. Inspect exhaust motors and belts for proper function. Repair and replace as necessary.
8. Remove all blockages from univents and exhaust vents to ensure adequate airflow.

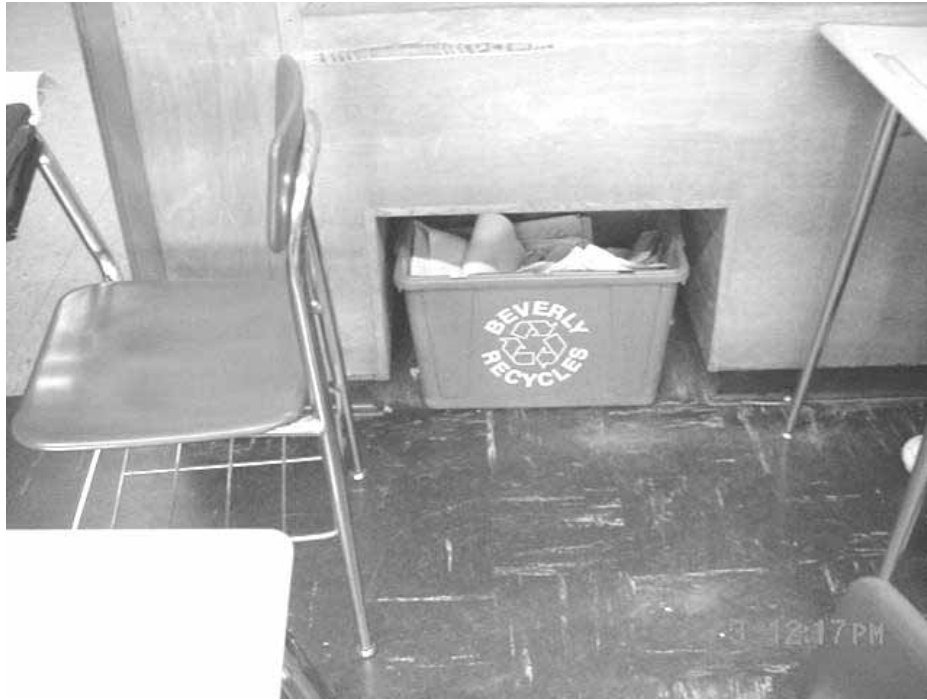
**Picture 4**

Exhaust ventilation is provided by grilled, ducted vents located in ungrated holes at floor level (Picture 4). Exhaust vents are connected to motors in a rooftop penthouse (Picture 5). No draw from exhaust vents could be detected during the assessment. BEHA staff and Mr. Bouchard visited the rooftop penthouse and found all exhaust equipment deactivated. Without mechanical supply and exhaust ventilation operating, indoor air pollutants can build up and lead to indoor air quality/comfort complaints. Exhaust ventilation in both the boy's and girl's restrooms was also not operating during the assessment.

**Exhaust Cubby at Floor Level Used as Storage**

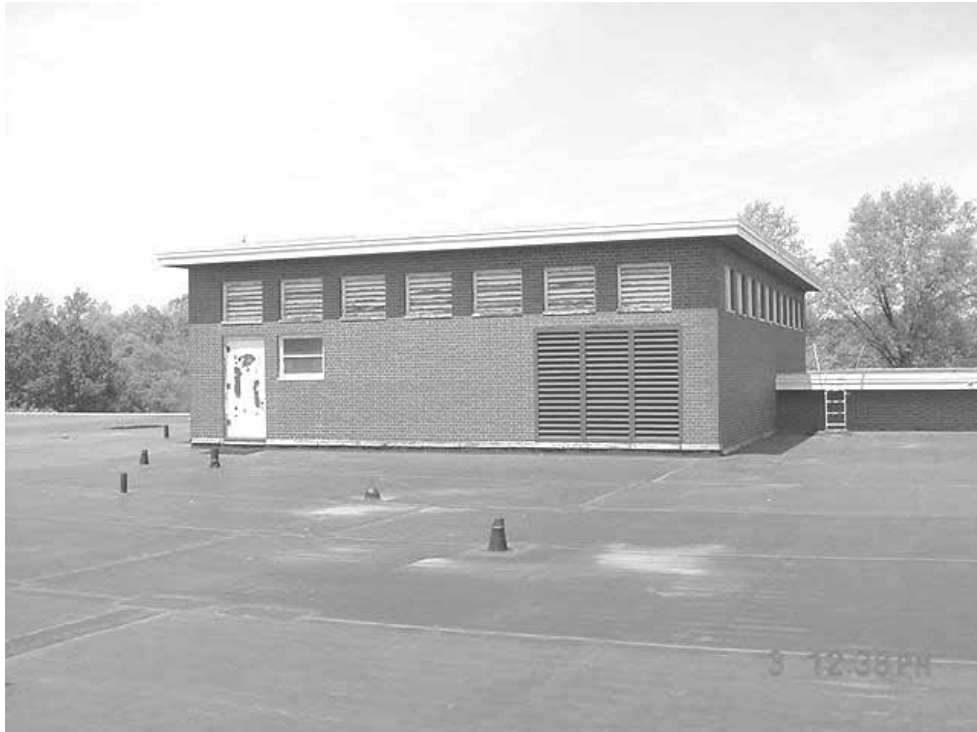
**Picture 5**

**Rooftop Penthouse for Ventilation Equipment**

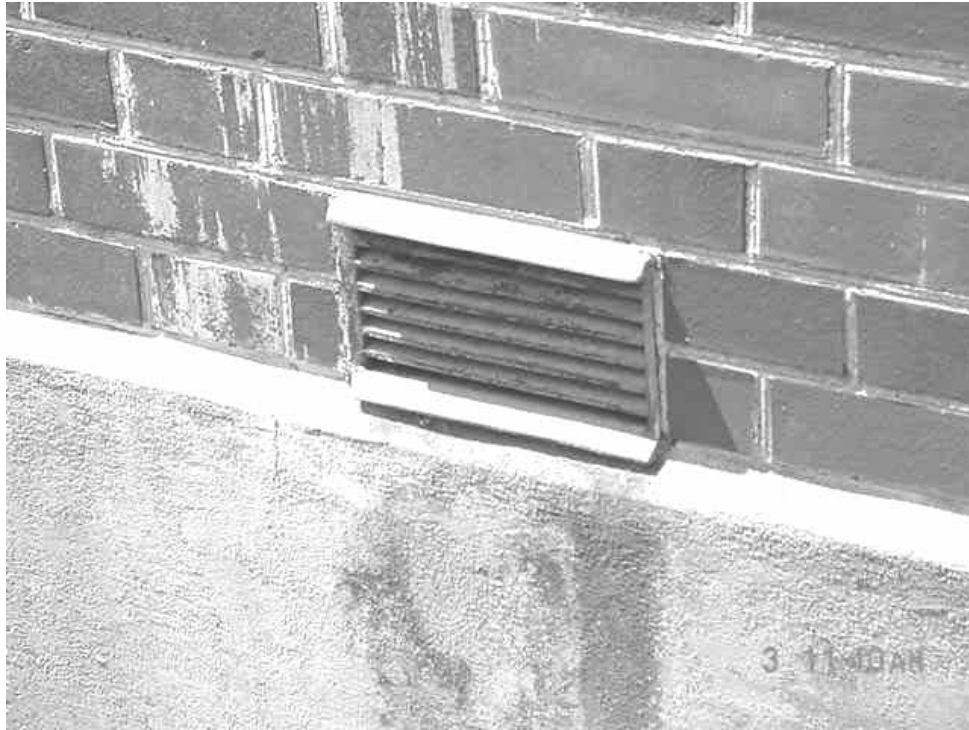
**Picture 6**

As previously mentioned, the focus of this assessment was to examine conditions in the crawlspace. The crawlspace consists of cement foundation walls and a dirt floor. The height of the crawlspace is approximately ten feet. No mechanical means of ventilation exists in the crawlspace. A number of crawlspace vents that allow for air circulation (Pictures 6 & 7) were observed. Relative humidity levels in the crawlspace ranged from 78 to 83 percent, which was at least 31 percent higher than any occupied areas. Relative humidity in excess of 70 percent can provide an environment for mold and fungal growth (ASHRAE, 1989).

**Passive Vent for Crawlspace**

4. Consult an HVAC engineering firm to determine the feasibility of providing mechanical exhaust ventilation to the crawlspace. The crawlspace should be placed under slight negative pressure to prevent air penetration into occupied spaces.

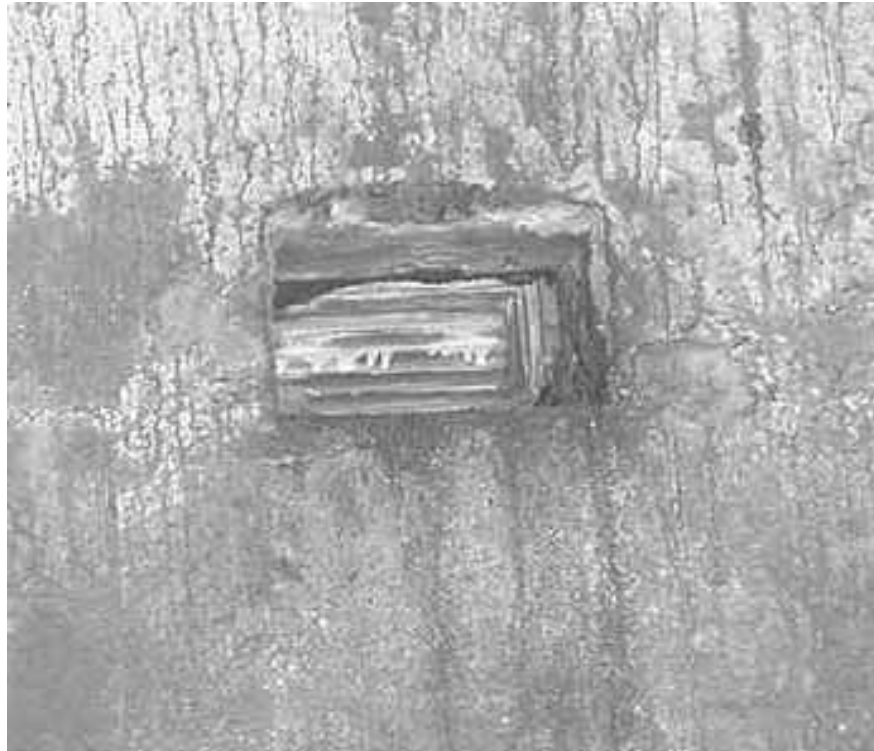
**Picture 7**

**Passive Vent for Crawlspace, Interior View Note no Mechanical Components**

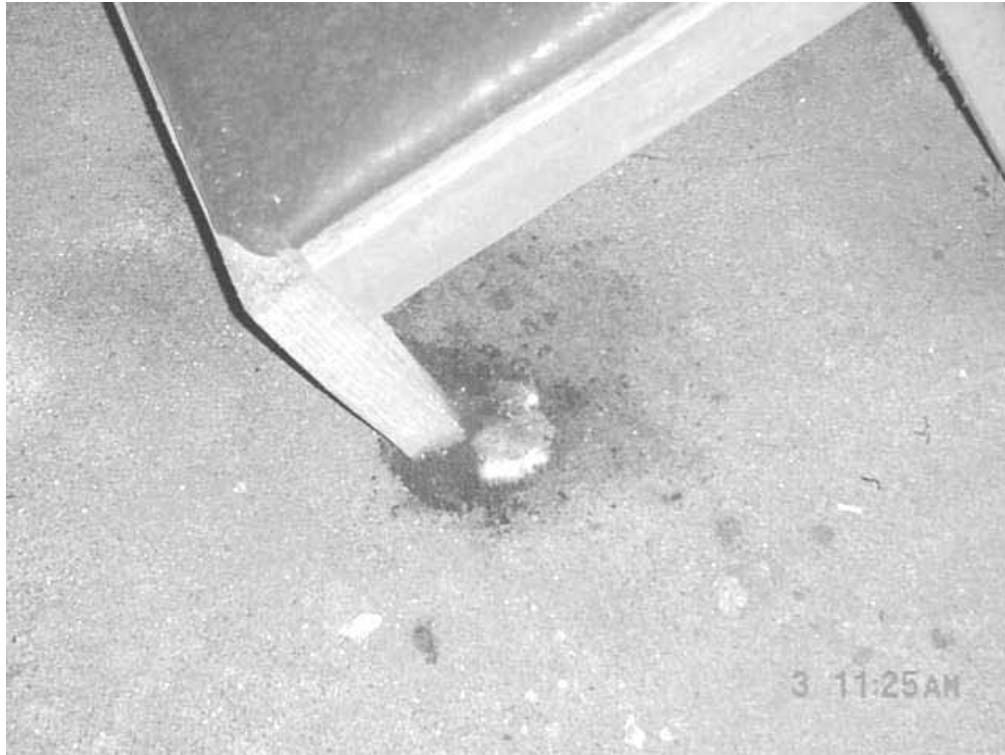
**Picture 8**

It appears that the crawlspace has been used for storage of discarded furniture and other classroom items for a number of years. Picture 8 depicts a severely water damaged wooden chair. Porous materials that can support mold growth (e.g. books, cardboard, paper and ceiling tiles) are stacked in piles on the crawlspace floor. Exposure to chronic moisture has resulted in mold growth on these items (Pictures 9 & 10).

**Chair Leg Disintegrated from Moisture Exposure, Dark Material on Ground is Remnants of Chair Leg/White Material is Mold Growth**

1. Seal utility holes and other potential pathways to eliminate pollutant paths of migration from the crawlspace to the first floor.
2. Remove any mold-contaminated materials (e.g. stored items) in the basement. Remove and replace (if necessary) any water damaged/mold colonized building materials. This measure will remove actively growing mold colonies that may be present. Remove mold contaminated materials in a manner consistent with recommendations found in Mold Remediation in Schools and Commercial Buildings published by the US Environmental Protection Agency (US EPA, 2001). Copies of this document can be downloaded from the US EPA website at: [http://www.epa.gov/iaq/molds/mold\\_remediation.html](http://www.epa.gov/iaq/molds/mold_remediation.html)

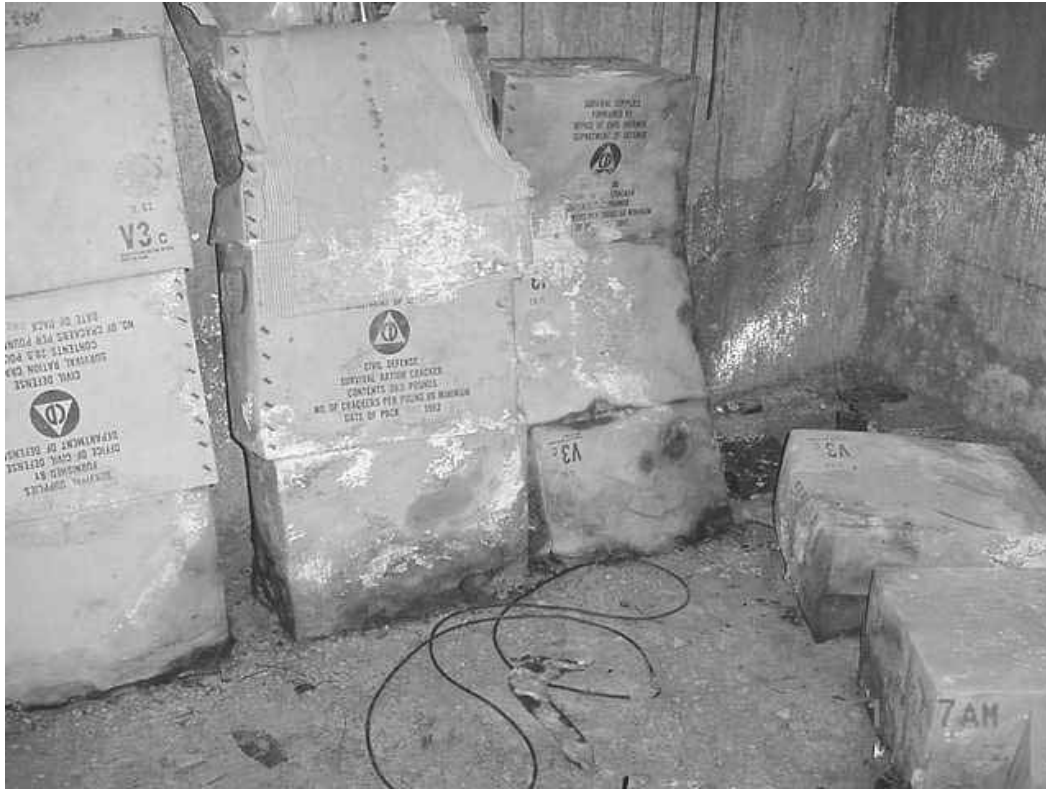
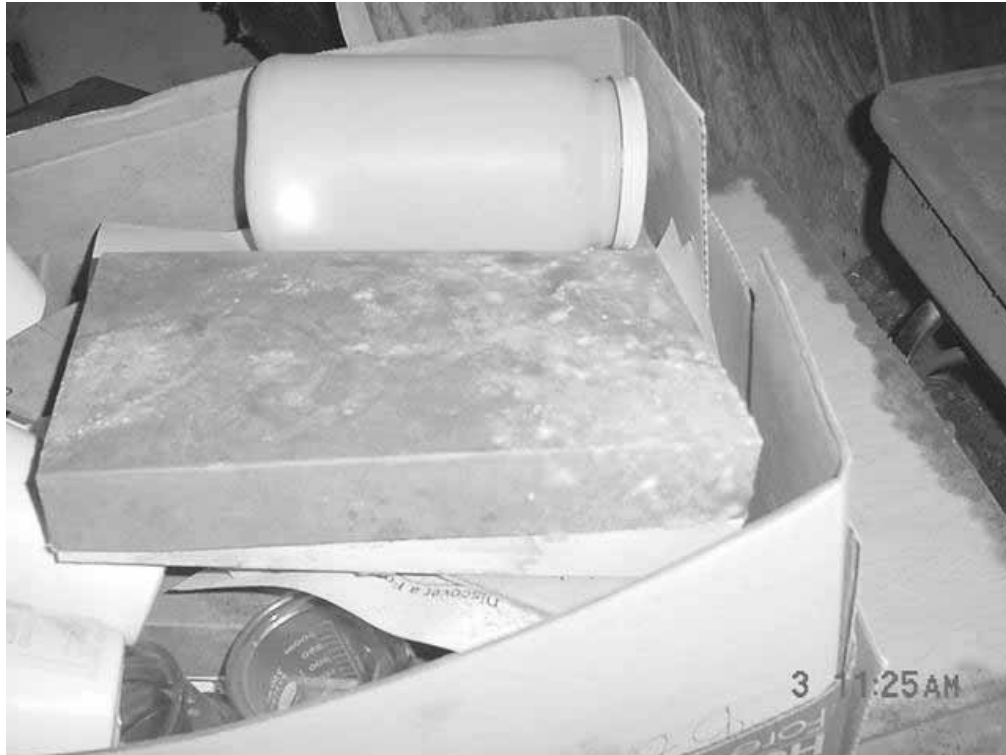
**Cardboard Boxes Colonized by Mold in Crawlspace**

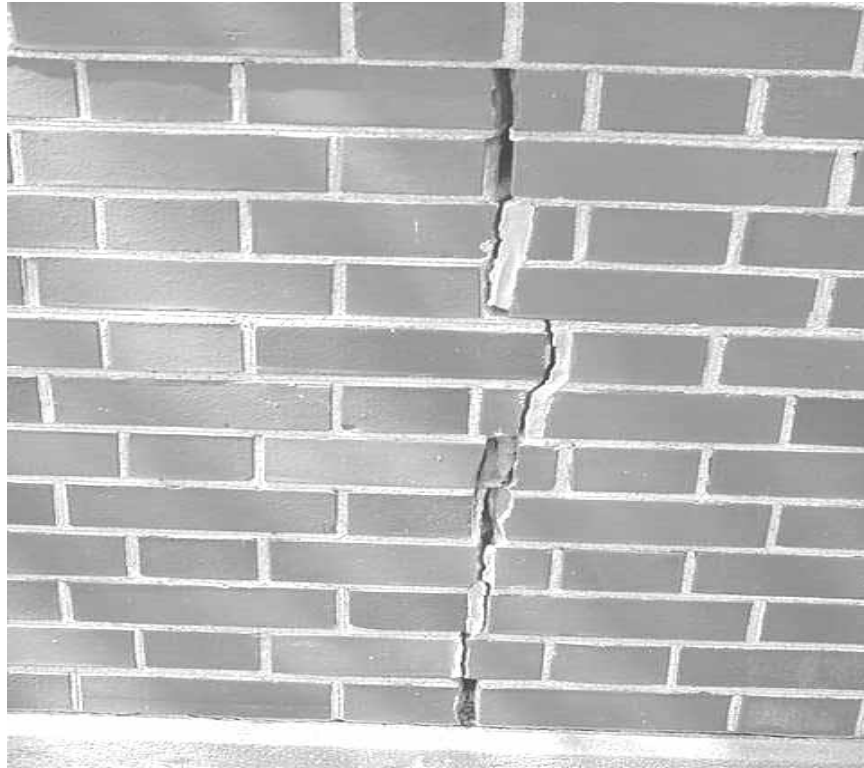
**Picture 11**

- Missing/damaged mortar around bricks and holes and spaces were observed in exterior walls (Pictures 11 & 12).
- Growth of small trees/stumps, and other plants in the tarmac/exterior wall junction (Picture 13) were seen along the perimeter of the building. The growth of roots/plants against the foundation/exterior walls of the building can bring moisture in contact with wall brick and eventually lead to cracks and/or fissures in the foundation below ground level.

**Missing/Damaged Mortar in Exterior Brick**

3. Consult with an architect and or general contractor regarding the integrity of the building envelope, primarily concerning water penetration through walls and the foundation. Examine the feasibility of repointing brickwork.

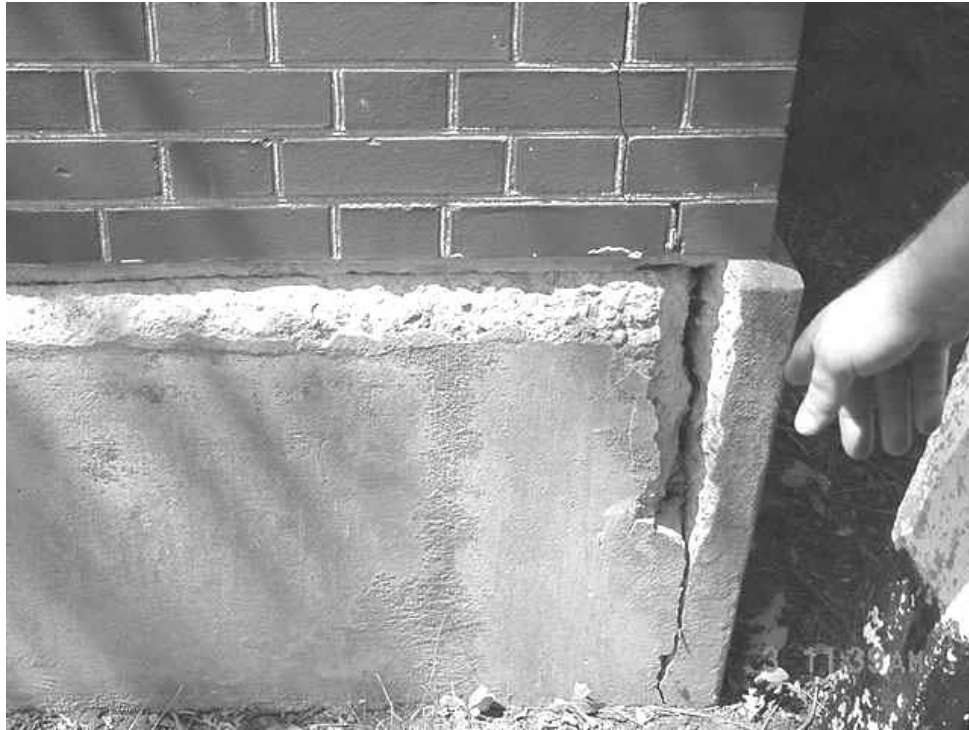
**Picture 12**

**Cracked/Damaged Foundation**

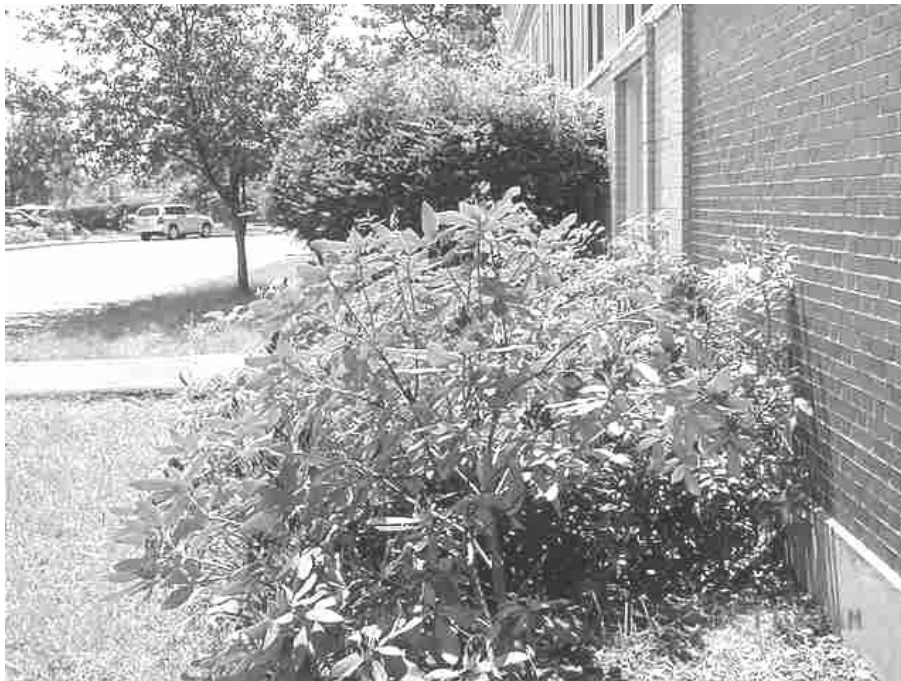
**Picture 13**

**Shrubbery/Plants Against Building**

10. Remove plants from the wall/tarmac junction around the perimeter of the building. Seal the wall/tarmac junction with an appropriate sealer.
11. Ensure all roof leaks are repaired. Repair/replace missing/damaged flashing along roof. Replace any remaining water-stained ceiling tiles (for dropped ceilings). Examine the areas above and around these tiles for mold growth. Disinfect areas of water leaks with an appropriate antimicrobial.

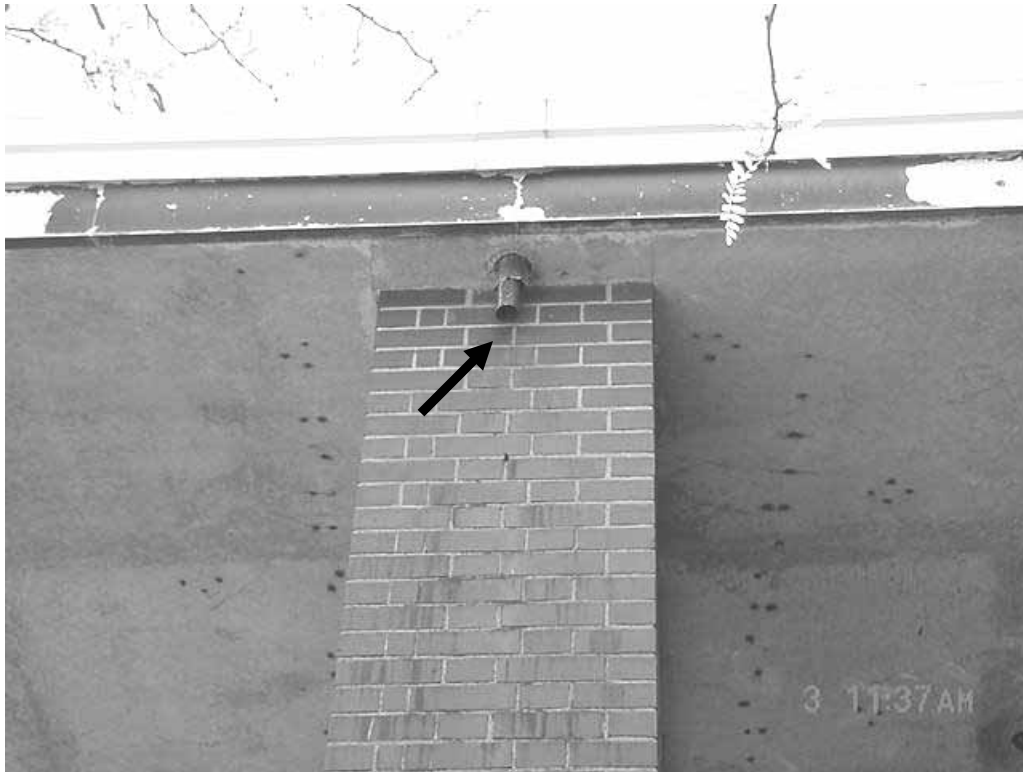
**Picture 14**

- Missing/damaged gutters and downspouts were seen in several areas along the roof (Picture 14). Gutters and downspouts are designed to direct rainwater away from the base of the exterior walls. In some cases the gutter/downspout system empties water directly against the foundation. These conditions can undermine the integrity of the building envelope and provide a means of water entry into the building through foundation concrete and masonry by capillary action (Lstiburek & Brennan, 2001).

**Missing Downspout**

13. Reinstall missing downspout in Picture 14 to direct rainwater away from the foundation.
14. Consult with a roofing contractor to prevent water pooling on roof shown in Picture 18.

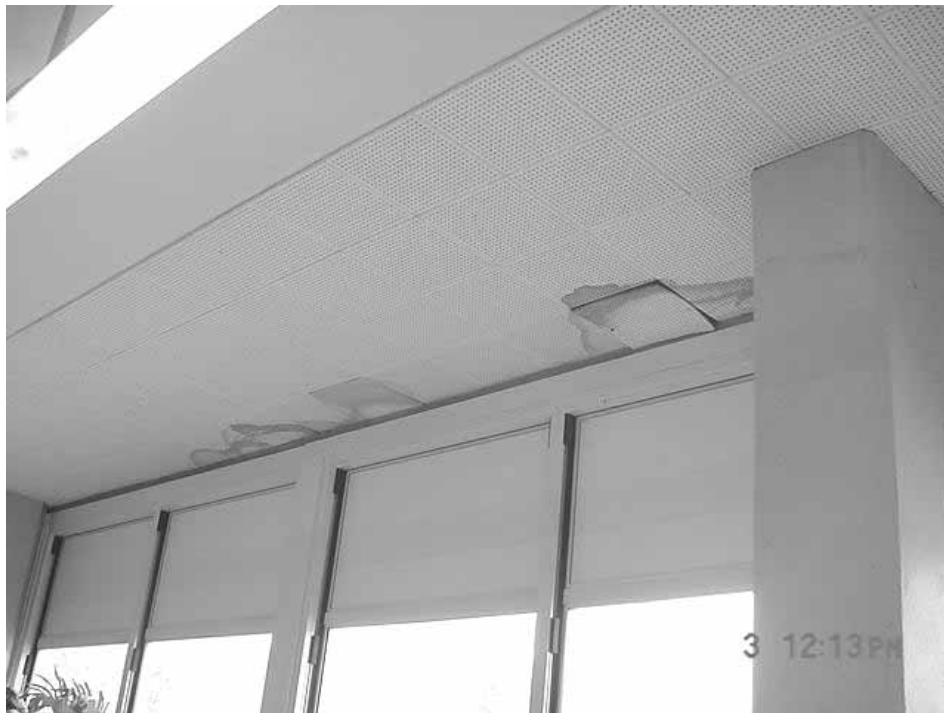
**Picture 15**

A number of areas had water-damaged ceiling tiles (Pictures 15 & 16), which is evidence of a roof or plumbing leak. In some cases damaged tiles have been directly adhered to the ceiling, which makes removal difficult. Water-damaged ceiling tiles can provide a source of mold growth and should be replaced after a water leak is discovered and repaired. Active leaks were reported in the cafeteria. Mr. Bouchard believed the leaks were most likely the result of

**Water Damaged Ceiling Tiles along Window Frame in Classroom**

12. For removal of tiles directly adhered to the ceiling, such removal would be considered a renovation activity that can release particulates and spores in particular, if the material is moldy. Replacement of ceiling tiles may involve glues that contain VOCs. In order to minimize occupant exposure, repairs should be done while the building is unoccupied.

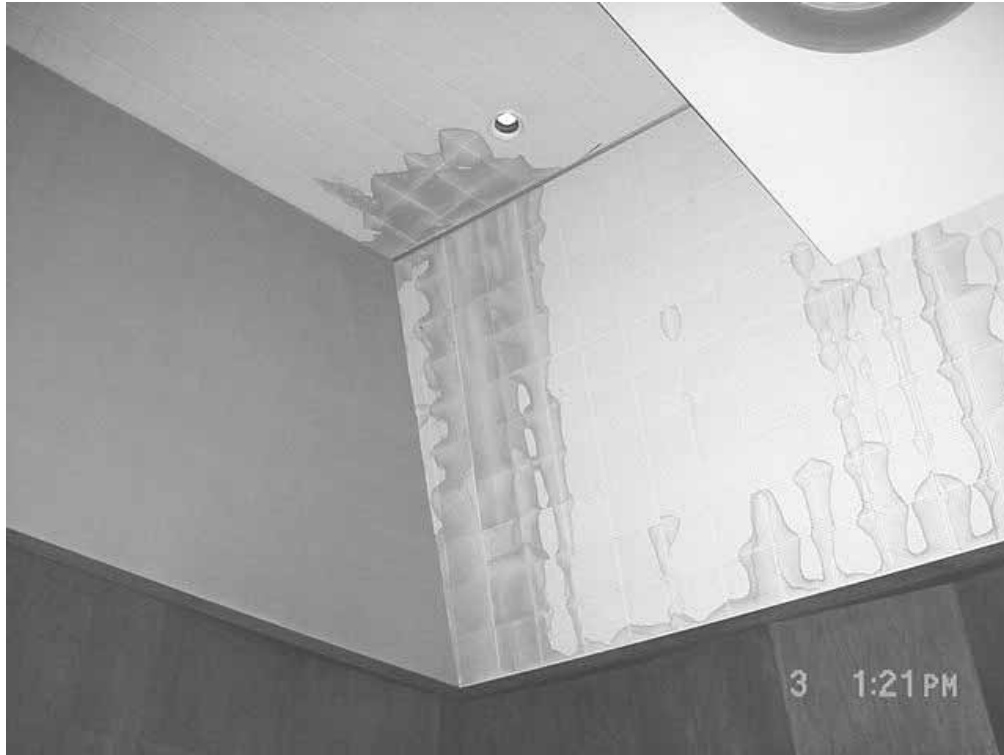
**Picture 16**

**Water Damaged Ceiling/Wall Tiles in Auditorium**

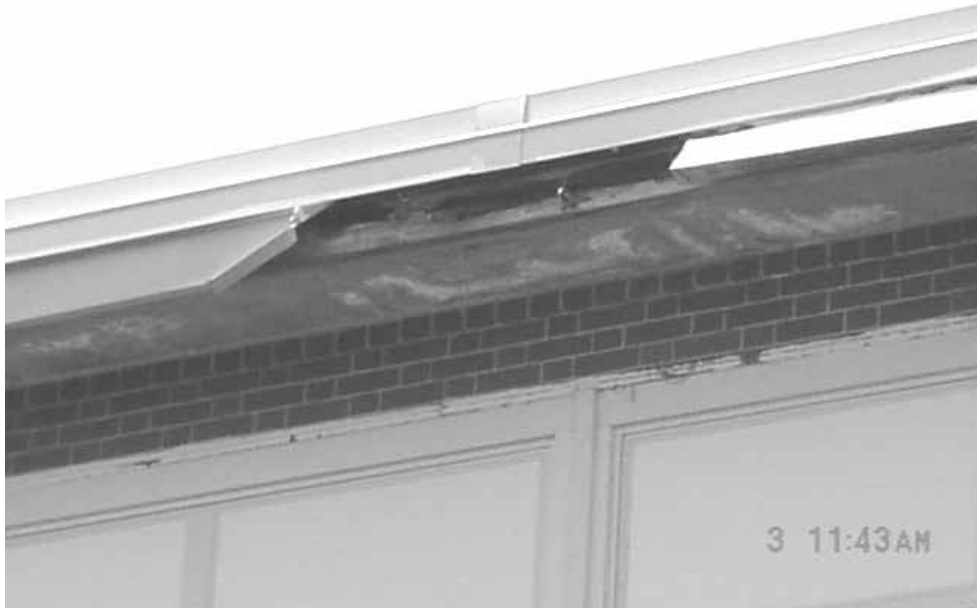
**Picture 17**

damaged flashing. Picture 17 shows an area on the exterior of the building where flashing is missing/damaged.

**Missing/Damaged Flashing along Roof**

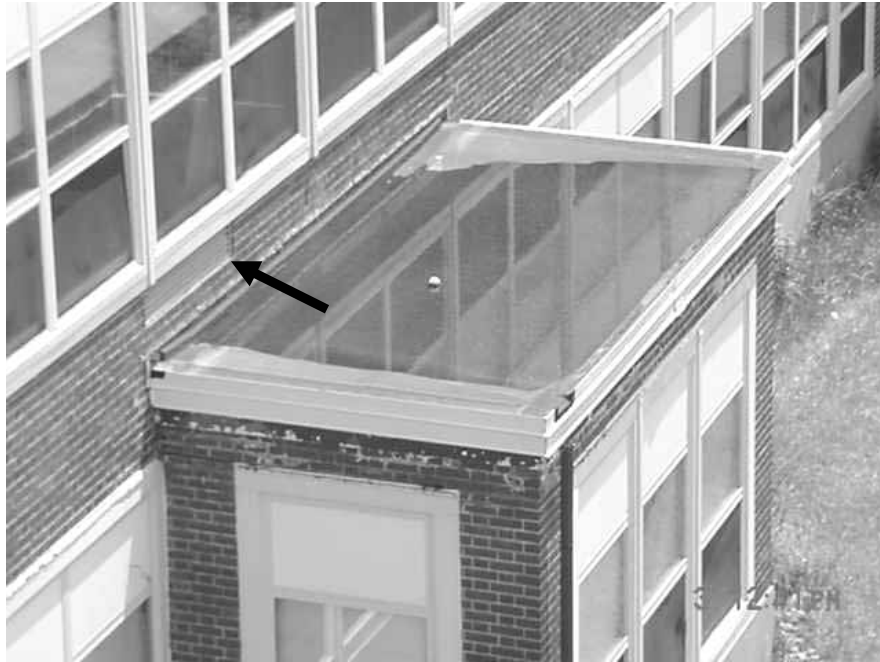
**Picture 18**

Finally, pooling water was observed on the roof outside of classroom 164 (Picture 18). Freezing and thawing of water during winter months can lead to roof leaks and subsequent water penetration to the building interior. Pooling water can also become stagnant, which can lead to unpleasant odors and microbial growth. In addition, stagnant pools of water can serve as a breeding ground for mosquitoes.

**Pooling Water on Roof Outside Classroom 164, Note Univent Air Intake**
